**MARYLAND HISTORICAL TRUST
NR-ELIGIBILITY REVIEW FORM**

Property Name: Samuel Thomas Farmstead Inventory Number: F-1-137

Continuation Sheet No. 1

Maryland Historical Trust State Historic Sites Inventory Form

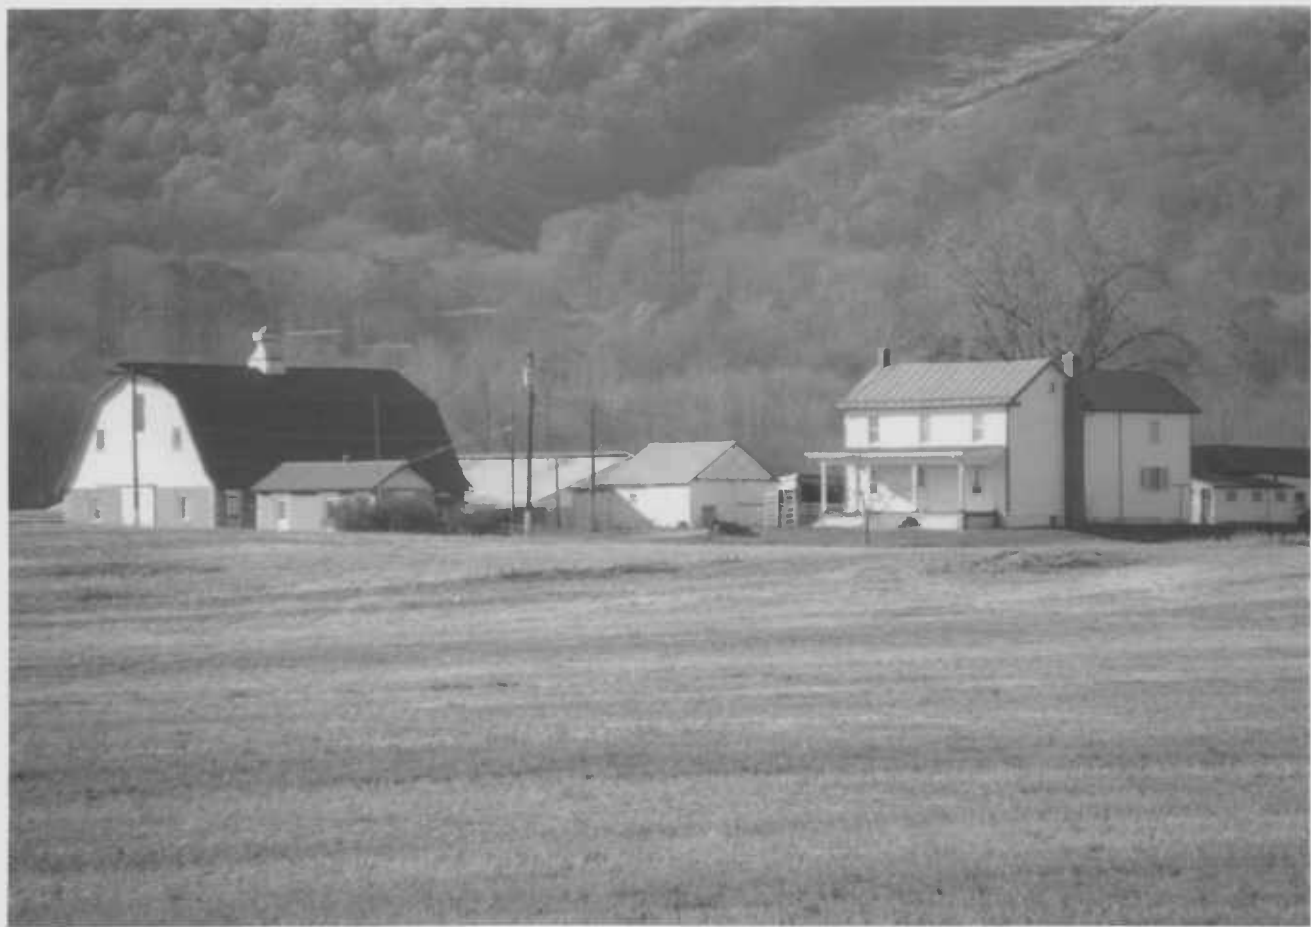
1/1

Overall, view W.

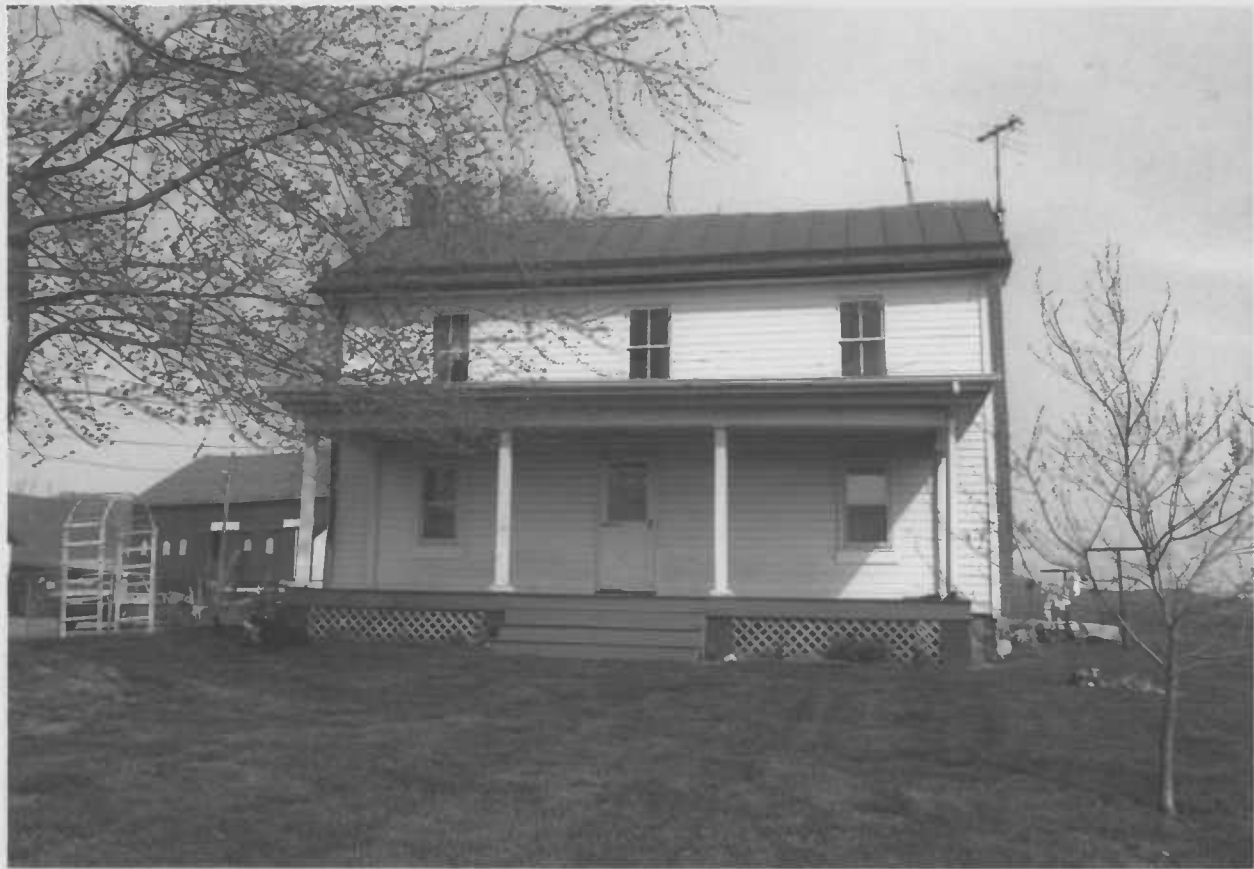
1/7

Southeast elevation

The dwelling has a three-bay main section with a two-story rear wing extending from the northwest corner built in two sections, the one adjoining the main section being log and the northwestern end being frame. The sections are demarcated by a vertical board over the joint in the exterior siding. The exterior is covered with german siding and the roof is standing seam metal, probably covering or replacing original wood shingles. An interior end chimney rises at the southwest gable end and the corresponding northeast chimney has been rebuilt on the exterior. A one-story porch extends across the entire southeast elevation, with square columns. The windows on the first story are 1/1 replacements and those on the second story are 2/2. The cornice is boxed with returns on the gable ends. The central entrance has a replacement paneled door and has no sidelights or transom. The rear wing has a one-story shed porch on the southwestern side, with square posts and an enclosed pantry at the northwest end. Each of the two sections has two bays, the log section having a boarded doorway. The sash is 1/1 on the first story and 2/2 on the second story as in the rest of the house. The door in the frame section is a glass-paneled modern replacement. On the northwest end of the wing, asbestos shingle siding over the german siding reveals the location of an exterior chimney which has been removed. The northeast side of the wing, which also is covered with asbestos shingles, has a modern picture window and the same 1/1 and 2/2 sash as on the rest of the building. A single 6/6 window on the second story of the main section may be an example of the original sash in the house. The interior of the house has been much altered with modern paneling, later partitions, and carpeting. A surviving mantelpiece in the first floor living room has columns and bull's-eye rosettes and appears to date from about 1835.

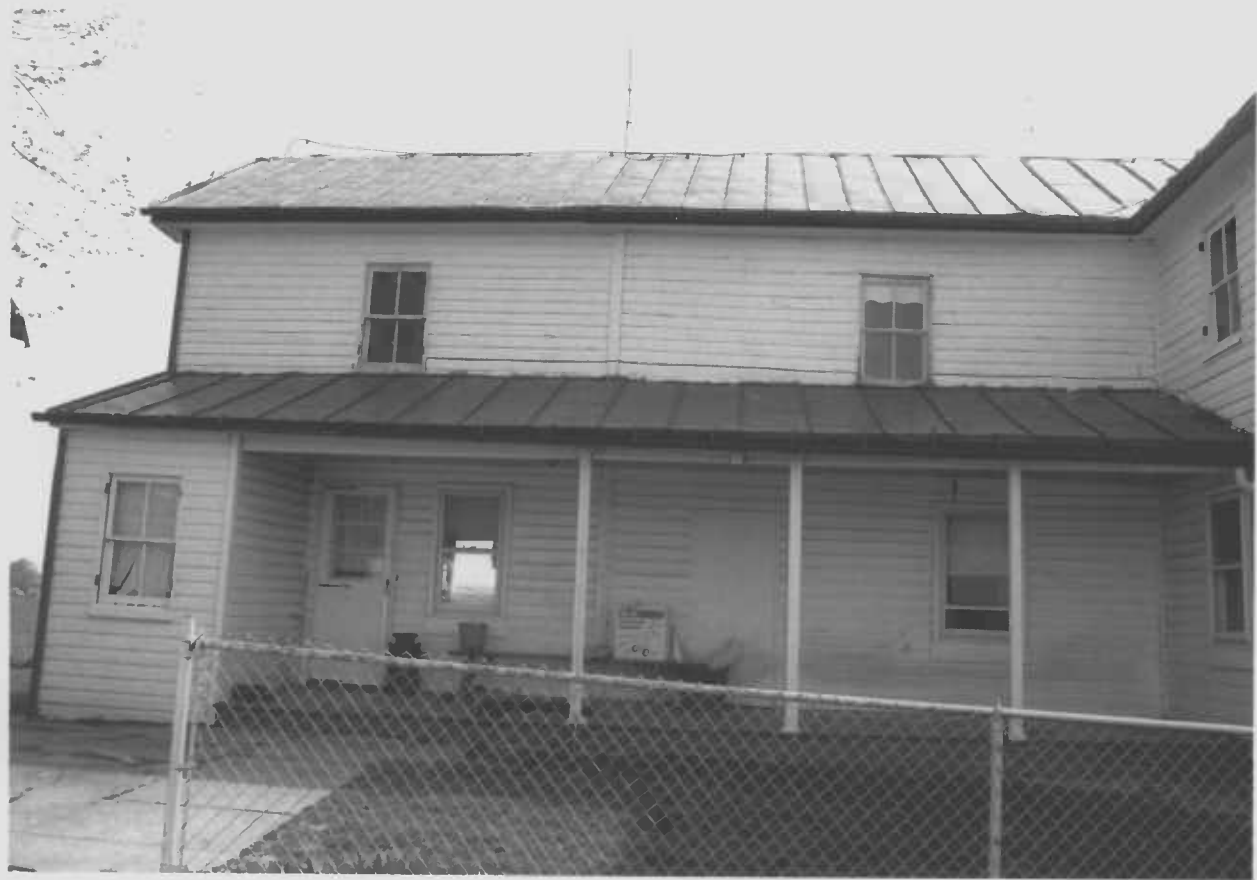
2/7

Southwest elevation of wing

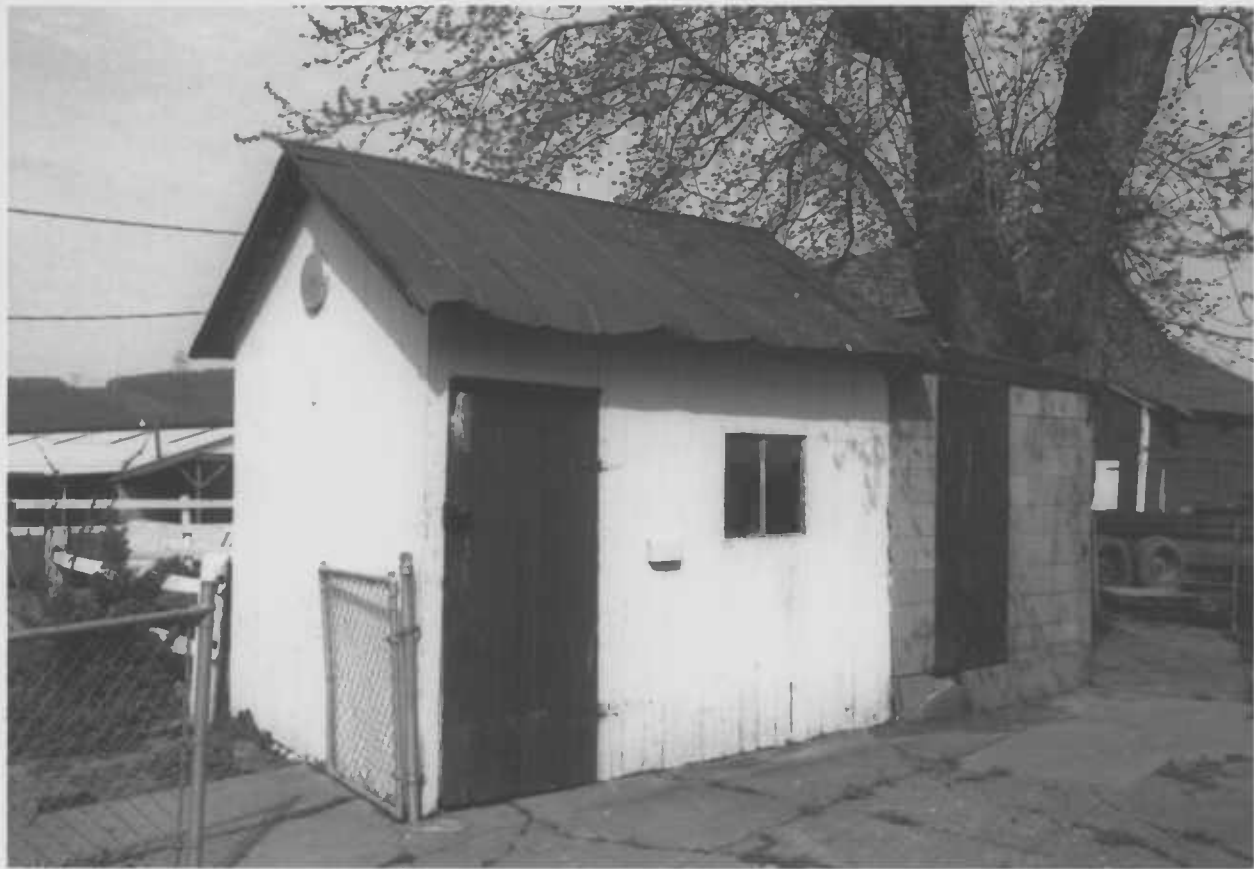
2/7

Dairy. Southeast corner view

Dairy: The small frame building located southwest of the rear wing is identified by Mr. Melvin Beachley, the current owner, as a dairy. It has tongue-and-groove siding, a standing seam metal gable roof and a single tongue-and-groove door near

the southeast corner. A small window with a vertical muntin is located next to the door. A concrete block addition adjoins the dairy on the north, with a second vertical board door. The dairy was probably built about 1910-1920, based on its materials. The dairy is located next to the raised concreted well and was used for milk can sterilization and storage.

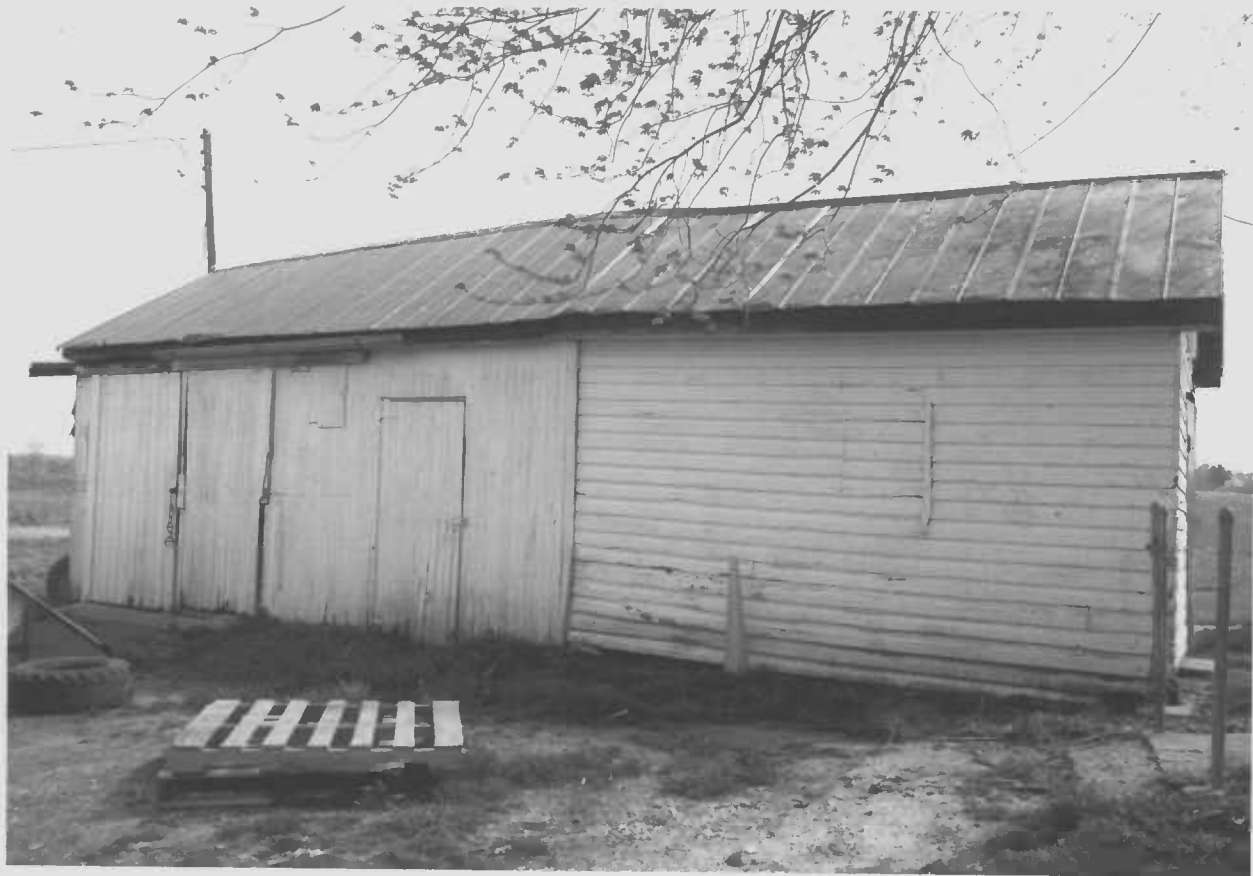
5/7

Meat house and addition. South elevation

Meathouse/summer kitchen: The frame meathouse is located northwest of the rear wing of the house. It is a rectangular structure with german siding and a standing seam metal roof. A single vertical board door is located in the center of the southeast elevation and a "jib" window opening, a covered opening in the same german siding, is located in the southwest elevation. On the south elevation above the door is a small screened opening at the gable peak. A shed-roofed frame addition on the northeast side of the meathouse was identified by Mr. Beachley as the summer kitchen. It has tongue-and-groove siding, a paneled door and a 3/3 window in the southeast elevation, and three 3/3 windows on the north side. Adjoining the meathouse on the northwest gable end is a frame shed of vertical tongue-and-groove siding with sliding doors and a swing door on the southwest elevation. This was apparently built for equipment storage, possibly in the 1920's. The meathouse appears to date from about 1890 and the summer kitchen addition about 1920.

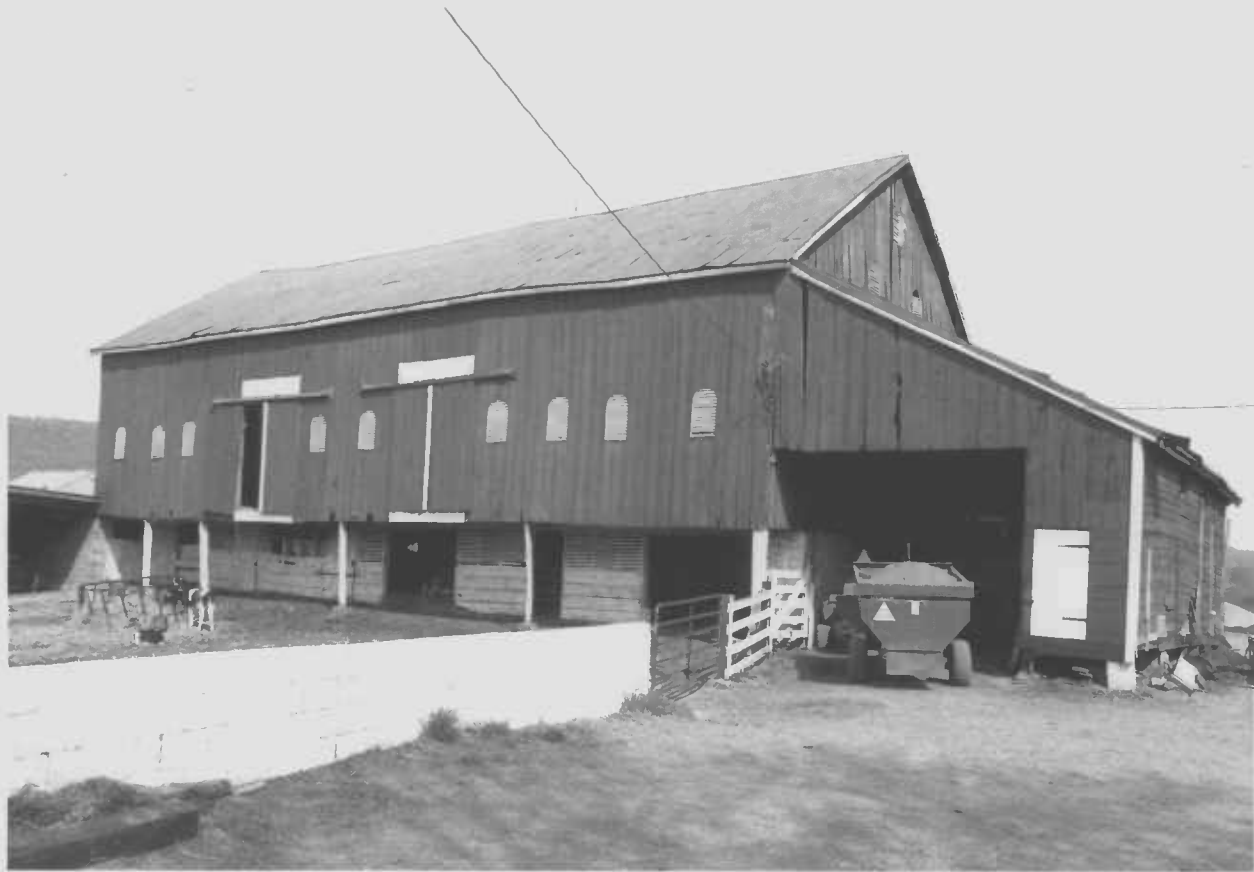
6/7

Bank barn, Southeast elevation

Bank barn: The frame bank barn has a stone foundation with the ramp to the barn floor on the northwest elevation. The exterior is covered with board and batten siding on the southeast elevation and northeast gable end. The rest of the building has vertical siding. The roof is covered with corrugated metal, over the original wood shingles. Louvred arched vents are located on all elevations. A shed addition on the northeast elevation is a wagon shed with corn crib on the outside wall. This appears to have been added about 1900. The barn itself may date from about 1875, having circular saw marks on the barn floor exposed beams. A non-contributing concrete block loafing shed adjoins the barn on the south.

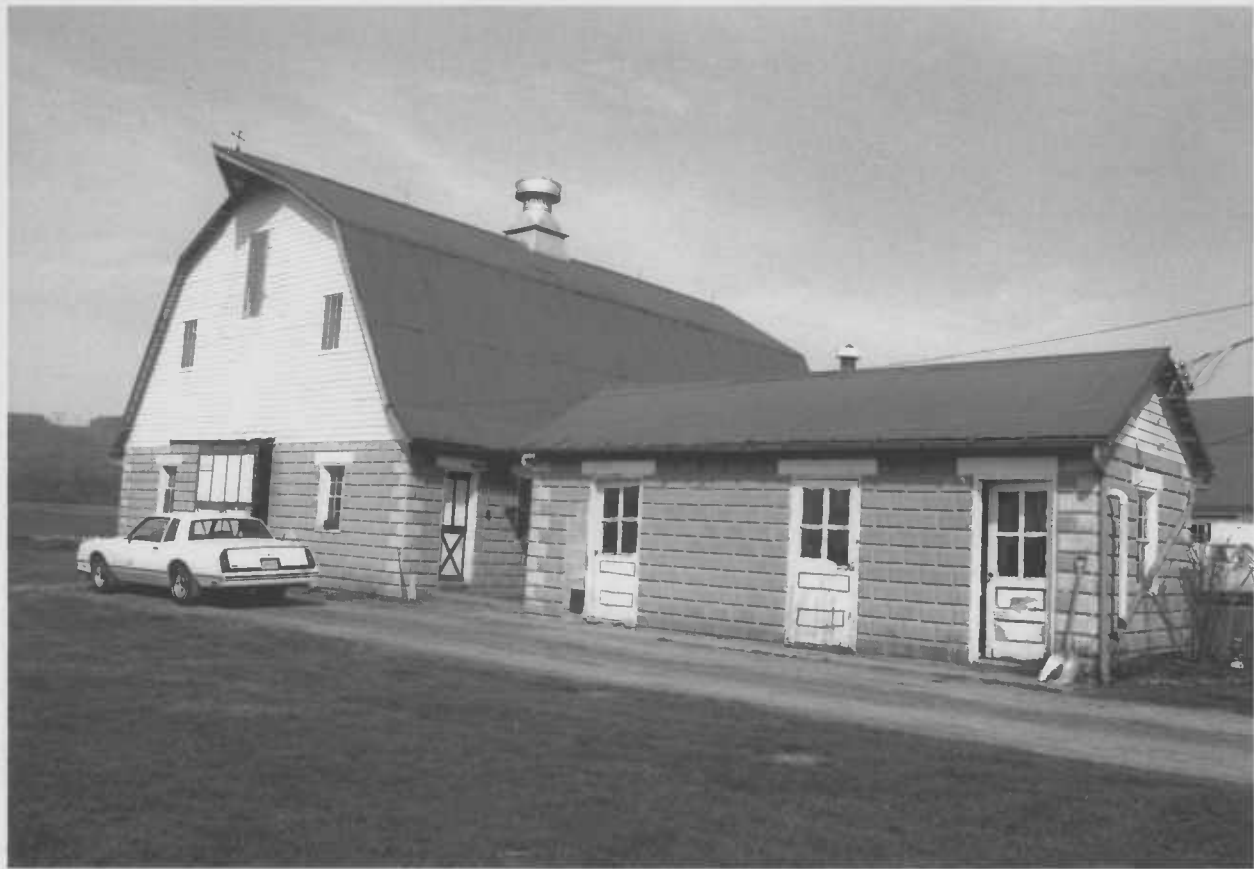
7/7

Dairy barn and milk house. View from
Southeast

Dairy barn and milk house: The rusticated concrete block dairy barn was possibly built during the period 1935-1940 and has lighter colored quoins, a gambrel roof covered with corrugated metal, and german siding in the end gables. The windows are 6/6 with plain lintels. The milk house is a rectangular building with three doors with glazed upper panels in the southeast elevation and 6/6 sash in the gable ends.
